DYNAMIC WIND LOADING ON OZ-POST SUPPORT  
OZ-POST™, INTERNATIONAL  
Test Report #CCLI-07-046

**Project:** Dynamic Wind Loading on Oz-Post™

COMPRESSIVE LOADING ON OZ-POST DECK POST SUPPORT  
OZ-POST™, INTERNATIONAL  
Test Report #CCLI-07-186

**Project:** Compressive Load Test on Oz-Post™

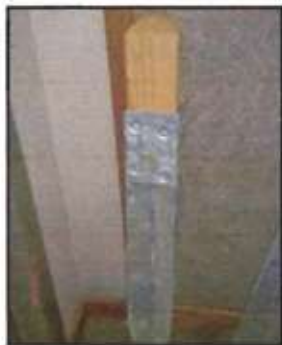
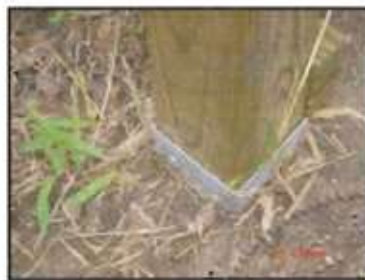
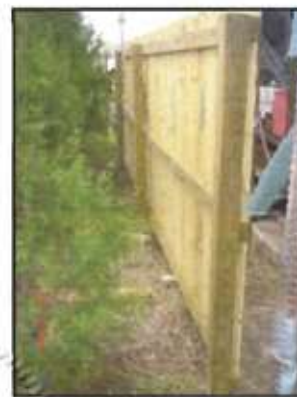
**GENERAL DESCRIPTION:** Oz-Post™, International T-4 850 Oz-Post™ Support was subjected to dynamic wind loading to simulate a hurricane force wind on a fence. The specimen's tested overall size is 16'-0" x 6'-0". The first specimen consisted of five (5) T-4 850 Oz-Post™ Supports spaced 4' apart with an embedment of 32". The second specimen consisted of three (3) T-4 850 Oz-Post™ Supports spaced 8' apart with an embedment of 32". A Pressure Treated Southern Yellow Pine 4" x 4" was then slipped into an Oz-Post™ support and attached with two (2) #10 x 1½" screws at each side of the post, total of eight (8) screws. Pressure Treated Southern Yellow Pine 2" x 4" rails are attached to the post with 10d nails, three per connection. 1" x 6" planks attached to the rails with 6d nails, two (2) per rail, total of six (6) nails.

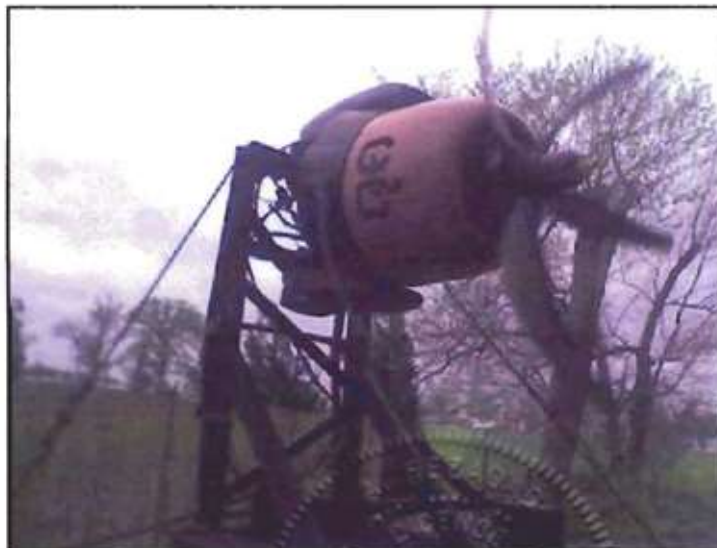
Winds were generated by a Curtiss Wright 3350 Radial Aircraft Engine with a 13'-6" diameter four (4) blade propeller. To measure the wind generated from the engine a 1½" diameter hole was cut through the fence plank at the center of the fence approximately 10" below the top edge. A Dwyer Mark II Wind Speed Indicator with 175 blue indicating fluid was inserted through the hole and two (2) Bruton hand held Atmospheric Data Center meters were used. One Bruton meter was installed at the end of test specimen and the other was moved by hand, spot-checking wind velocities. The engine rigid mount pitot tube along with test console airspeed indicator were also used to measure wind speed.

**5-Minute Test Results:** The fencing along with the Oz-Post™ remained fully embedded in the soil. There was no visible damage and no separation of the wood posts to the Oz-Post™ supports during the test. At test conclusion, there was a permanent set of 1" at the top mid-span of fence. Rocking the fence back and forth at test conclusion resulted in an observed ¾" movement of the Oz-Post™ in the surrounding soil.

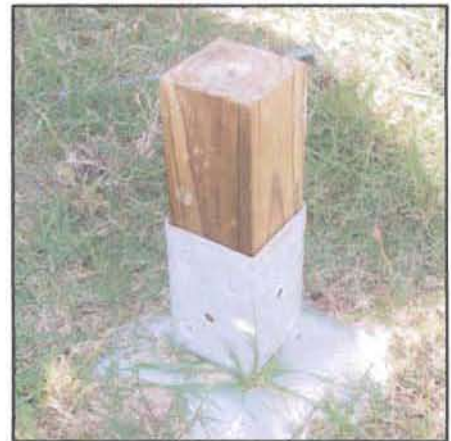
The post assembly consisted of the Oz-Post™, International T-4 850 Oz-Post™ and OD-T-4 Oz-Deck Deck Plate. The T-4 850 Oz-post inserts through cross-slots in the OD-T-4 Deck plate and as a post assembly was driven into a native North Texas regional soil using an Oz-post designed pneumatic jackhammer. The soil characteristics such as moisture content, void ratio and other parameters were not known at the time of testing. Upon contact between the deck plate and the soil, the hammer was allowed to dwell on the post for a period between 1-2 minutes to seat the plate onto the soil.

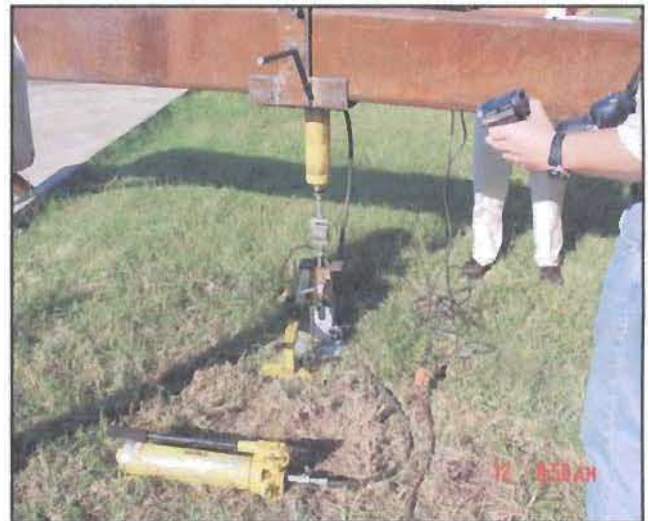
The downward compressive test load was applied with an Enerpac hydraulic ram and cylinder. The test load was measured with an Omega S-Type load cell and indicated with an Omega digital indicator, Calibration Date effective till August, 2008 by Nicol Scales. The hydraulic cylinder was mechanically attached to a steel tube fixture with the ram and load cell aligned directly above the post assembly. Chicago dial indicators with maximum movement indicator arms were positioned on the test fixture, deck plate and the deck post to measure the amount of movement during the compression loading.
