OZCO Project #111 - Wooden Mailbox Post Assembly

Overview

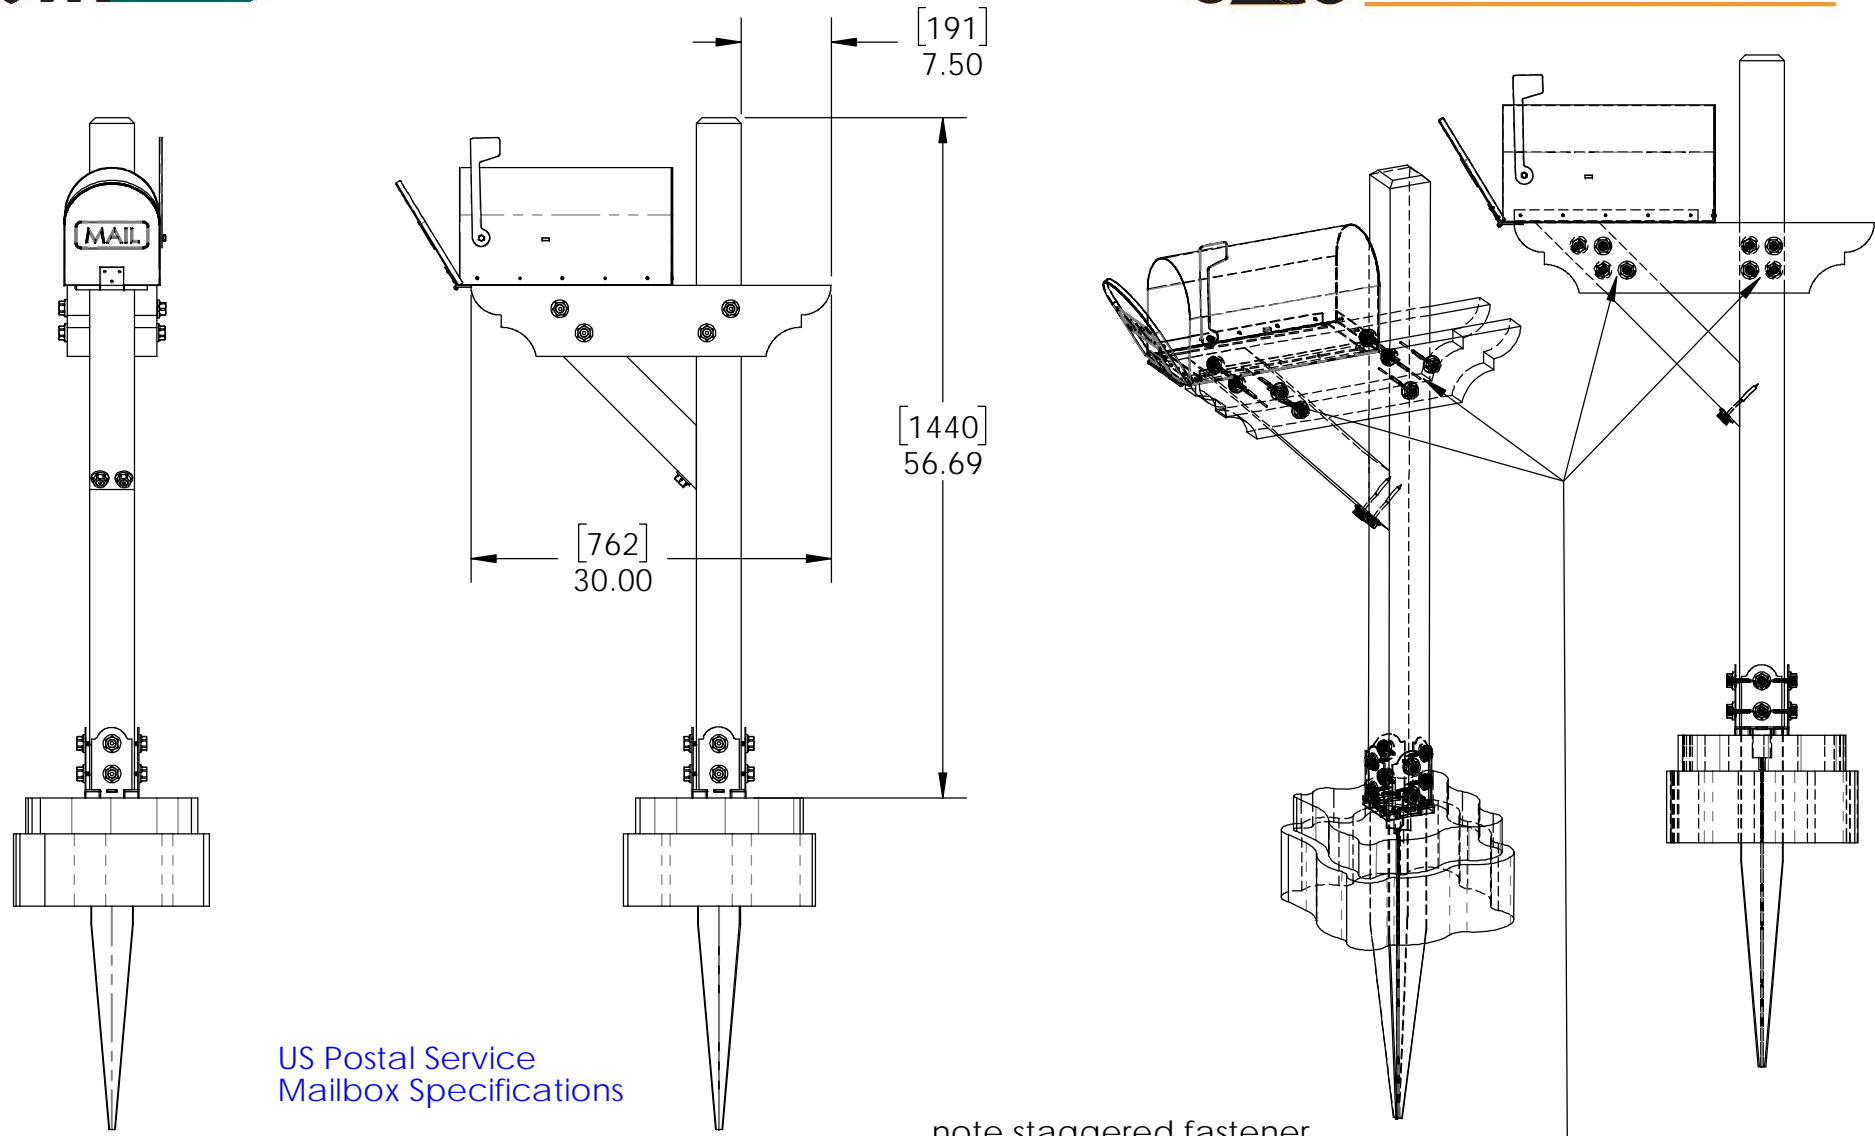
US Postal Service
Mailbox Specifications

note staggered fastener
pattern to eliminate collision

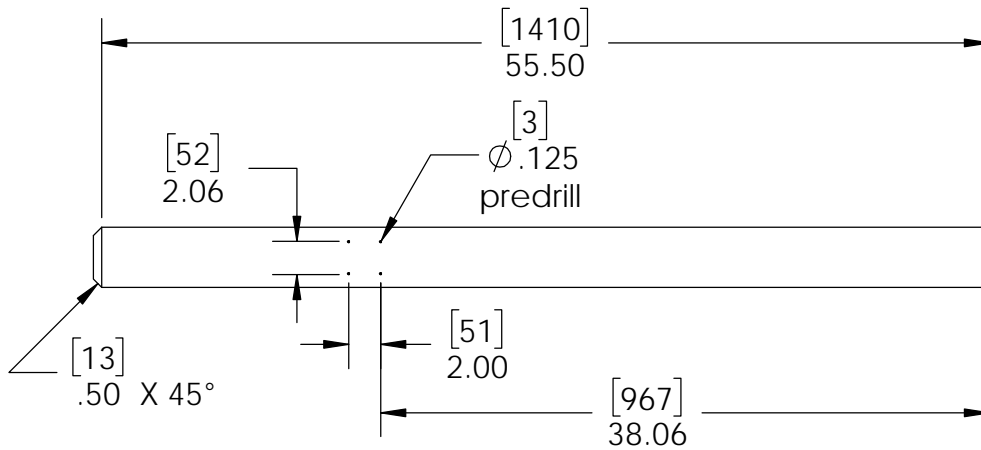
Cutlist

4x4x96
cut all pieces from from 1 post
